**PILLINGS POND DAM**

**MA 00239**

**PHASE I INSPECTION REPORT  
NATIONAL DAM INSPECTION PROGRAM**

**AUGUST 1978**

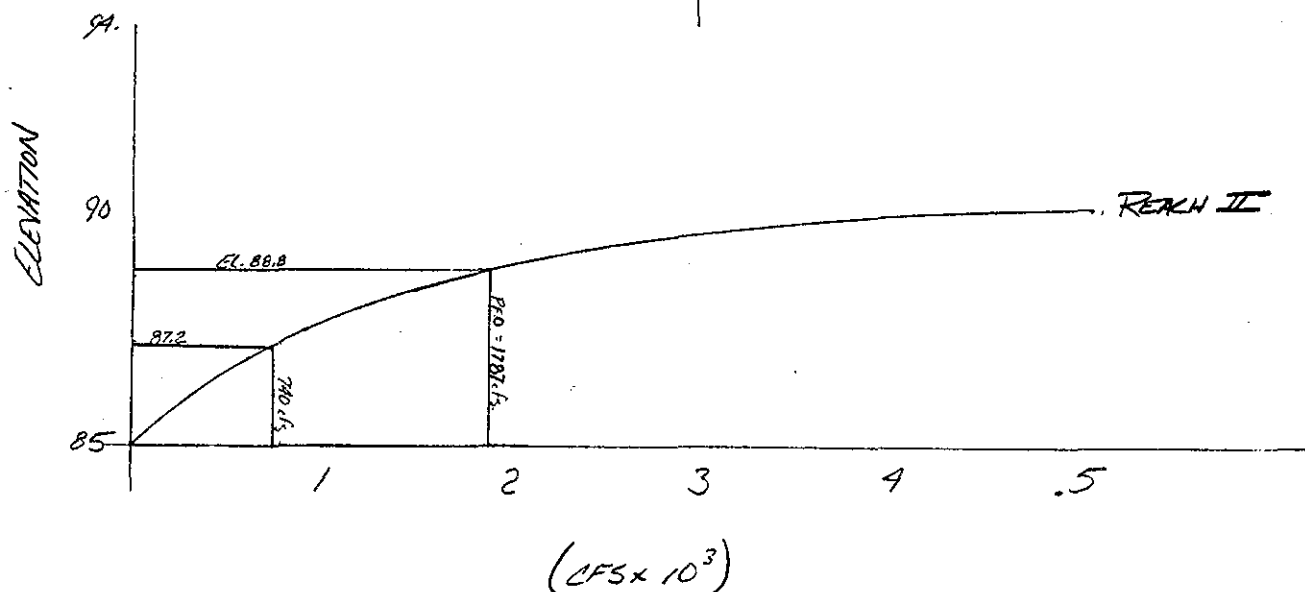
ASSUMING NO STORAGE THROUGH REC. POOL  
 $Q = 1787$  cfs EL. 88.8' to Walnut Rd.

Some slight property - ACROSS WALNUT ST. directly into large SWAMP - NON  
 flooding in REACH II no danger to life.
